Hopwood Corn Mill

A report on the general condition of the remains

Middleton Archaeological Society (MAS)

Cliff Ivers December 2014

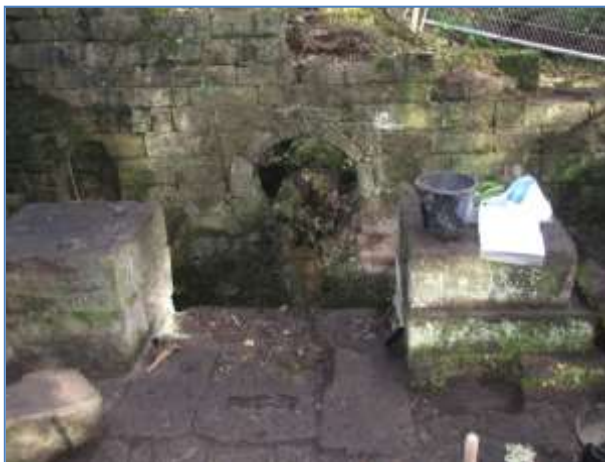
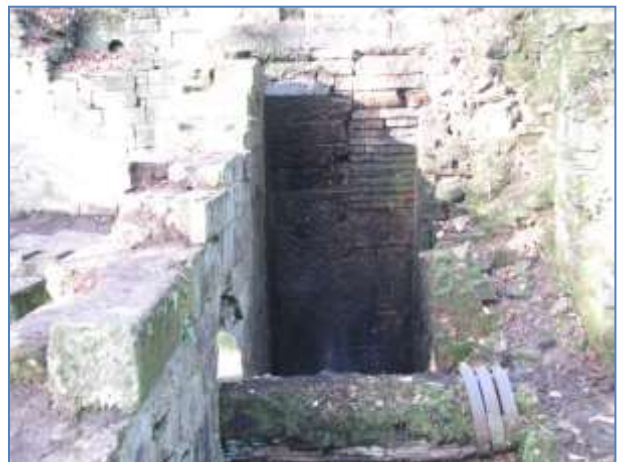
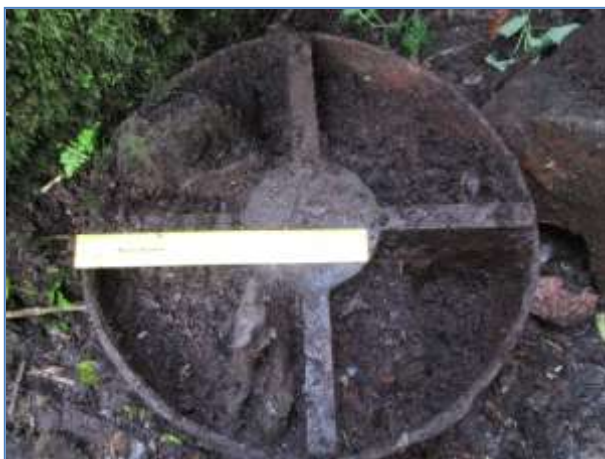
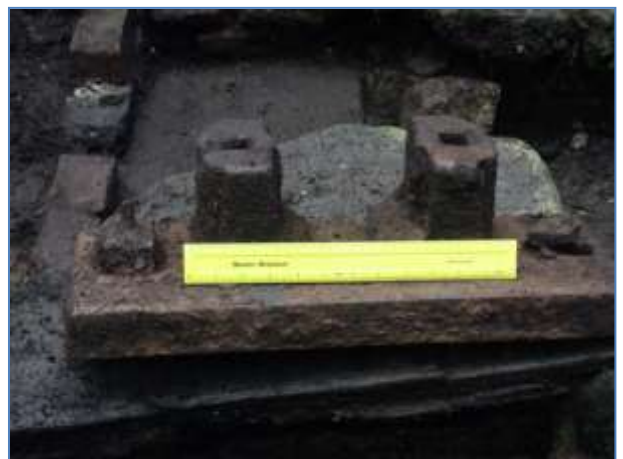
1. The **southern and western walls** of the old mill had been partially rebuilt in the 1970's using stone from the original building. Consequently, when GMAU carried out their investigation in 2003 the walls were excluded from their report. A 2m length of the south wall has fallen over but remains intact. Also the reconstructed doorway and stone lintel have collapsed with the lintel sited several yards away.
2. The **wooden axle tree** has suffered from further rot at its western end. The axle's cast iron journal and bearing stool had fell into the pit wheel pit. The bearing stool was cleaned and given to Hopwood College staff for safekeeping. The journal was too heavy to lift so was left in the pit. The eastern axle bearing remains in position but is badly rusted due to exposure to the weather.

Figure 1 west and east views of axle, western bearing journal and stool

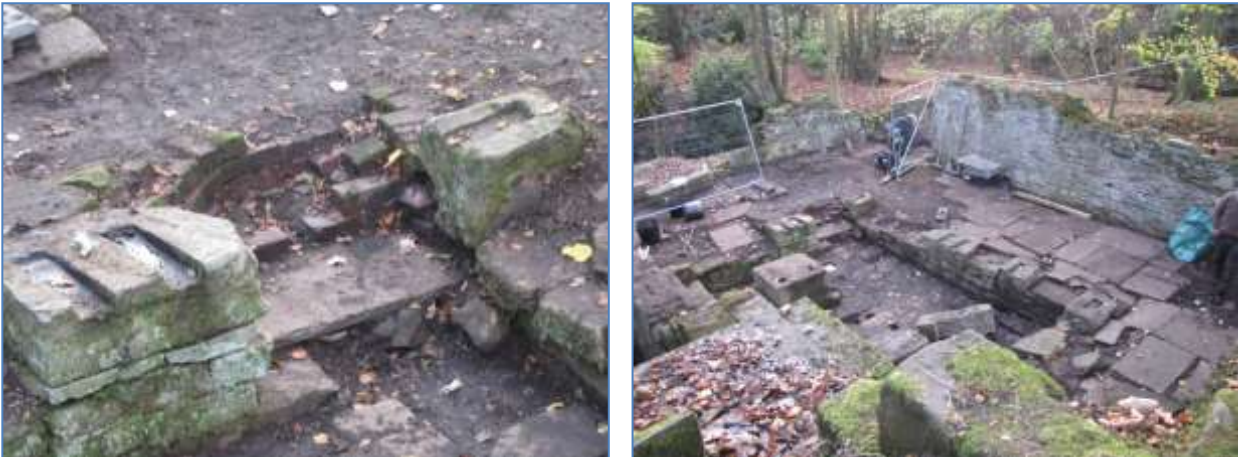
3. The **mill floor** appears to have suffered little physical damage since the plan was drawn by GMAU in 1993. Following the clean-up, nineteen missing pieces of stone flooring were identified and have been highlighted in red in appendix one. There are a number of stone blocks with uniform sized slots on the top edges located on the mill floor. It is believed that these were main joist for the kiln that was located to the west of the mill. These were re-used for the expansion of the mill in the 19th century. The smallest main joist has been dislodged from its original position.

Figure 2 main kiln joists reused in gear cupboard and the mill floor

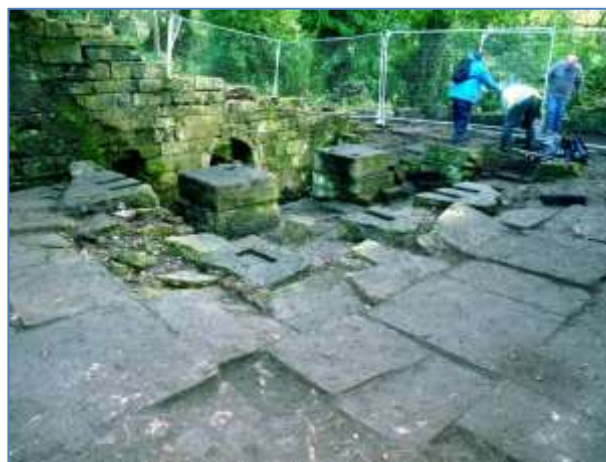
4. The **wheel pit wall** was examined and its condition is drawn in appendix one. Seven large ashlar finished blocks have gone from the top of the wall. The wall has been used as a shortcut down from the millpond and stones have probably been dislodged by vandals. The stones appeared to be located in the wheelpit but were too heavy for MAS members to move. Several of the stones at the top of the wall were loose due to the deterioration of mortar. However this may suggest that the top of the wall has been rebuilt. The circular axle hole in the wall looked in generally poor condition and will probably be the next part of the wall to collapse.

Figure 3 Western face of wheelpit wall and supports for branch tree

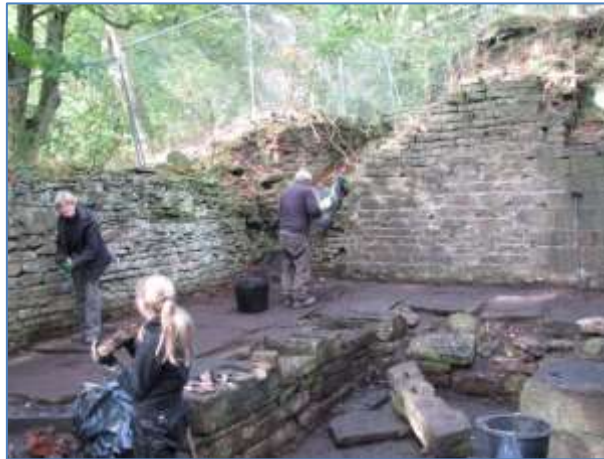
5. The **north wall** lies against the mill dam and consist of three different building phases. The ashlar blocks in the centre and western end remain largely as they were in 1993. The later addition of handmade bricks at the eastern end of the wall was probably associated with the drying kiln. Approximately 25 of these bricks have been dislodged probably due to rain fall from the steep embankment above the wall. It should be noted that MAS members are not civil engineers and cannot comment on the structural strength of this or any part of the ruins.

Figure 4 The north wall

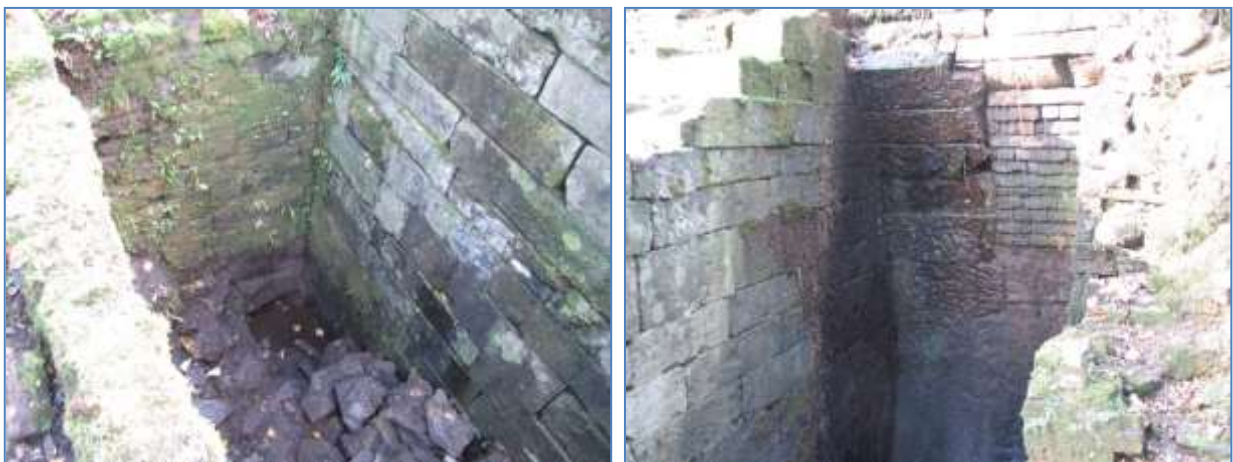
6. The **wheel pit and pit wheel pit**. Both these structures were in sound condition but had been partially filled with debris that was removed. MAS were unable to remove large pieces of stone from the bottom of the pits. The wheelpit was never fully cleared by GMAU and is one of their recommendations. MAS managed to clear access to the tailrace lintel at the southern end of the wheel pit and extracted several loose handmade bricks (180x120x50mm) which could suggest an earlier build at this location.

Figure 5 wheelpit south showing tailrace, wheelpit north showing expansion work

1. *Total excavation of the wheel pit.*
2. *Total excavation of the corn kiln to expose the remains of the furnace which must occupy the ground floor.*

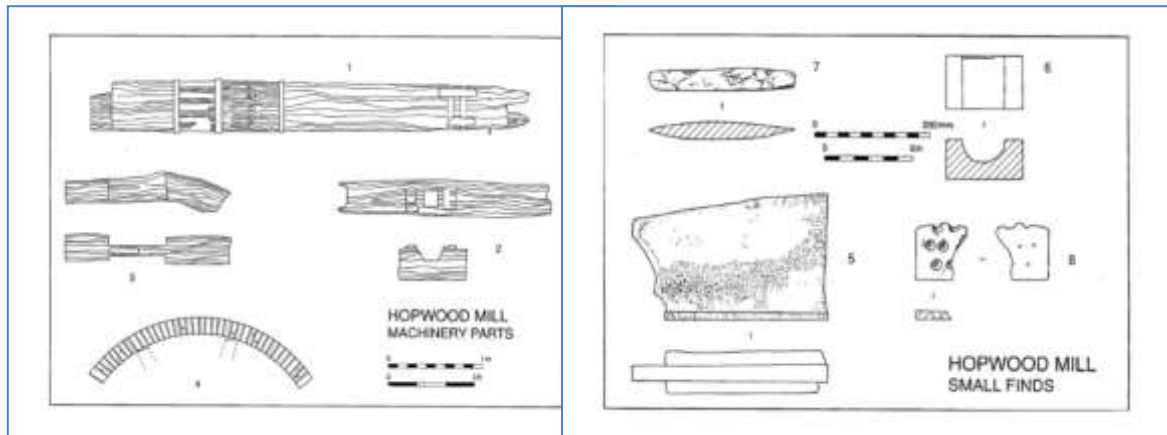
- 7. Finds.** Apart from the axle bearing support previously mentioned, MAS did not record any finds at the clean-up days. GMAU recorded 5 large machinery parts and 8 small finds in their report. The College were unable to locate these at the time of the clean-up but it is believed that at least one (cast iron fragment of pit wheel) is stored in Hopwood Hall. The remainder of the large parts were timber components and may have suffered further deterioration

Figure 6 GMAU 1993 Finds

5. *The large timber elements which remain at the site, formerly parts of the mill machinery, are slowly deteriorating with exposure to weathering. These require treatment with appropriate preservative materials to stabilize their condition to the standard suitable for permanent outdoor display.*

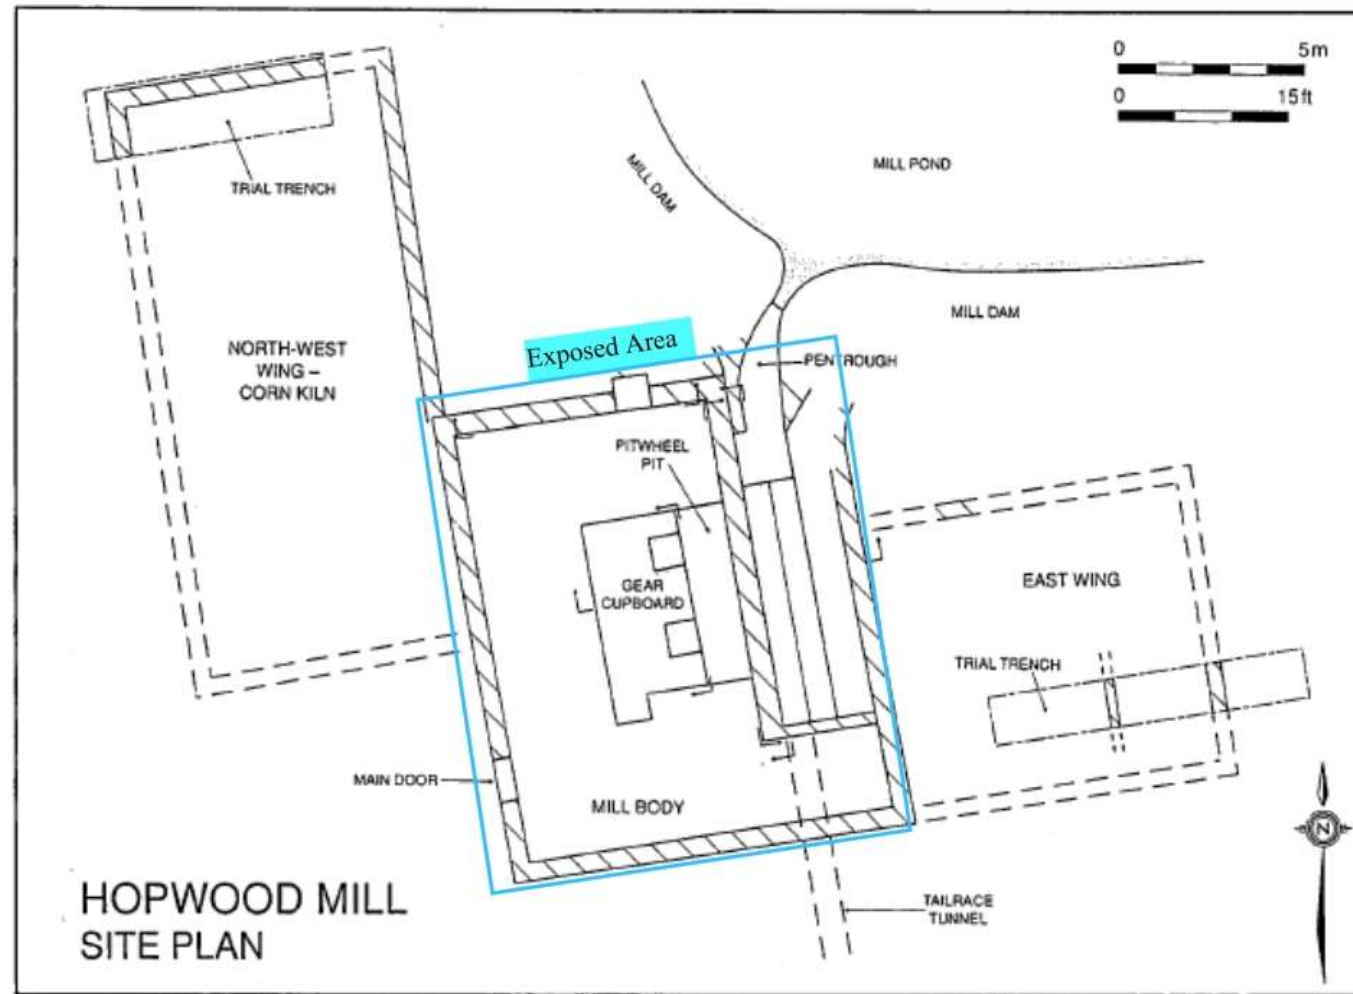
APPENDIX ONE GMAU 1993 PLANS WITH MAS ANNOTATIONS

Areas in pink indicate missing items.
