Summary of
Archaeological Excavations at
Tonge Hall Meadow
Middleton,
Greater Manchester

2012 -2014

Robert J. Huddart

Middleton Archaeological Society

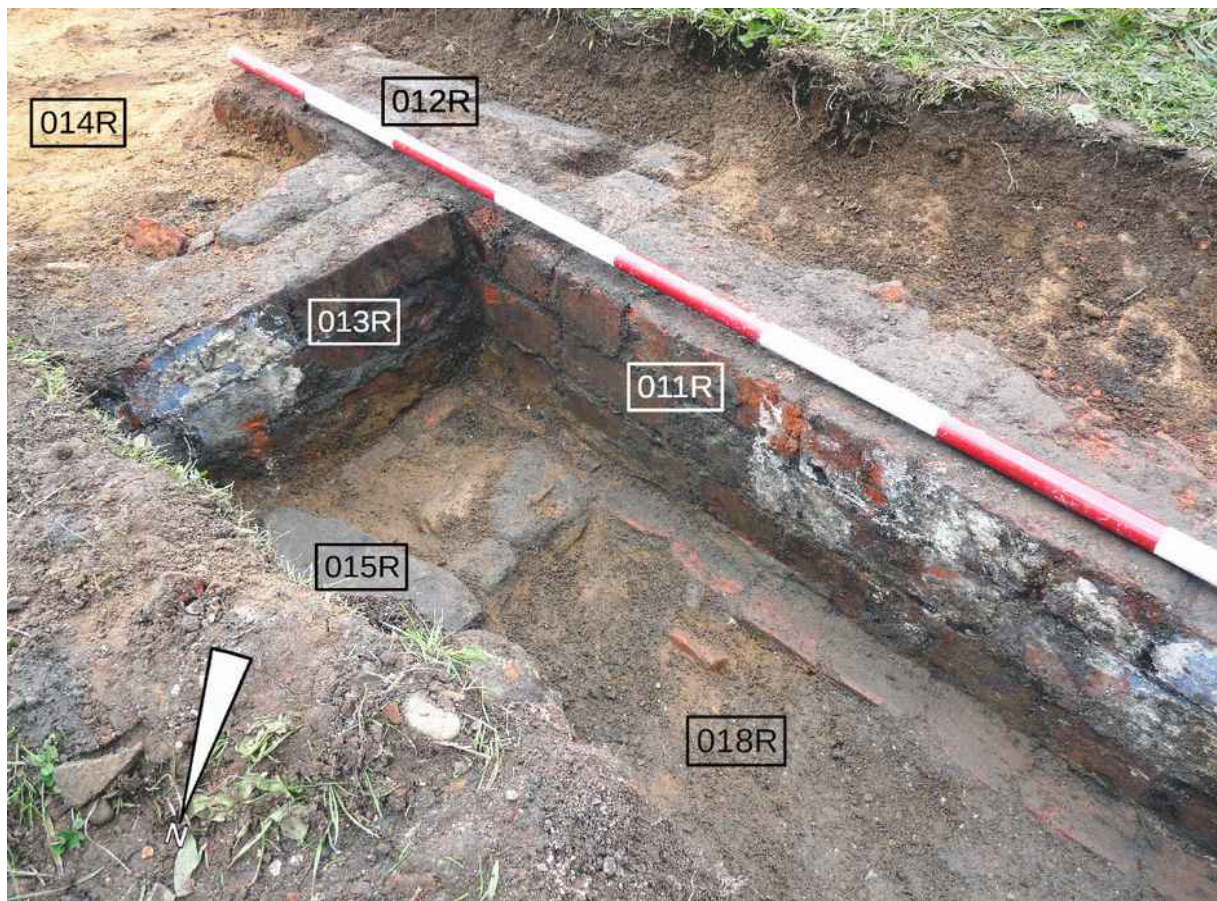
Tongue Hall Meadow Trench 03 - October 2012

Excavation revealed a section of wall with a total length of about 2.1 metres. The wall appears to have been constructed in 2 phases. The northern section is 1.6 m long [011R] and is butted against the shorter and probably earlier section measuring about 0.5 m [012R]. At the join of the two wall sections a second wall runs eastwards at 90 degrees to the first wall for about 0.5 metres before entering the trench section [013R].

The walls are constructed from a double row of machine made brick laid with stretchers and without a cavity. They stand to 3 courses on a foundation layer of a single course of brick laid with headers. The mortar, where visible, was dark grey. No mortar was visible in the shorter wall [012R]. The walls were cut through the natural sand [014R] with the foundation laid on the underlying clay [018R].

The eastern (internal) area has the fragmentary remains of a stone paved surface [015R] set directly onto the natural clay [018R]. At the northern end a vertical metal pipe was found in situ [018R]. Traces of coloured wash were still present on the inner wall surfaces.

TP 03 was reopened and extended to 1m x 4m.

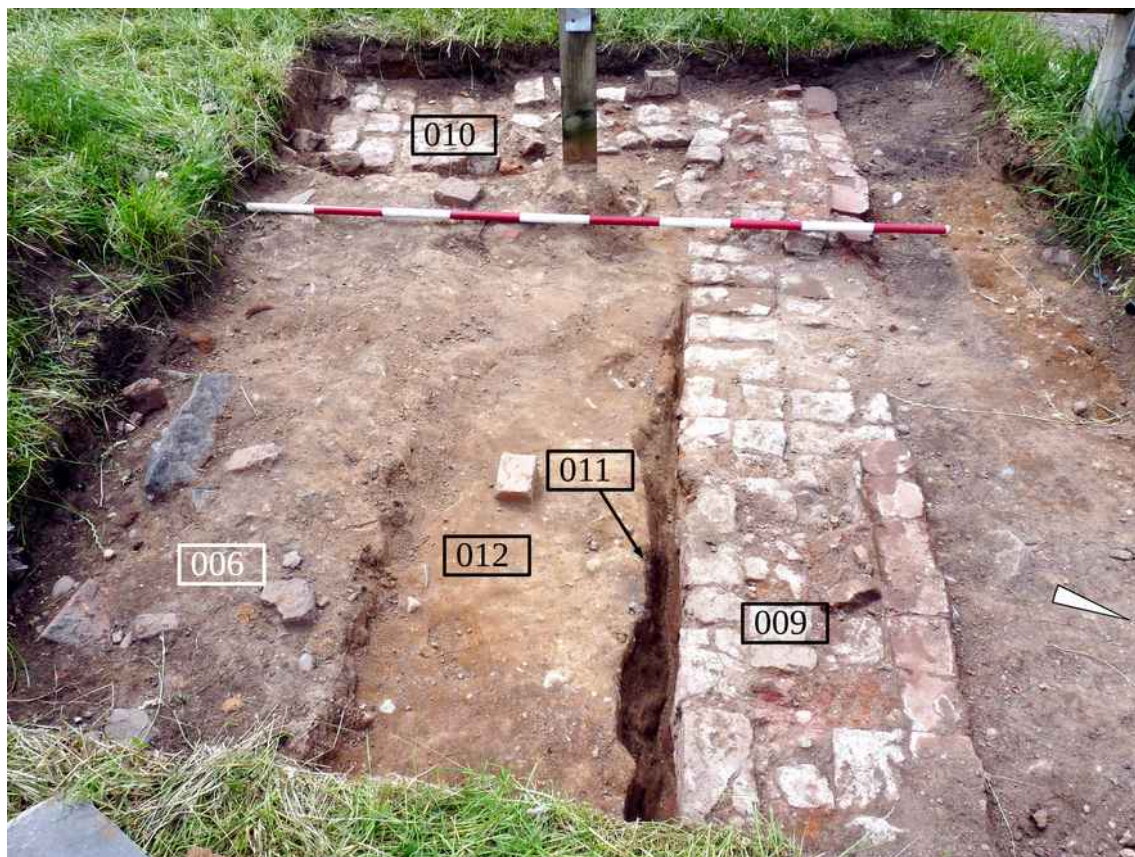
Tonge Hall Meadow Trench 05 – July 2013

A 3.2 metres of the north wall foundation [009] and a 1.6 metres of the west wall foundation [010] was exposed during the excavation.

The north wall was constructed from 4 rows of brick laid with stretchers. The first 3 rows on the south side were of hand made brick whilst the fourth row on the north (external) side of the building was of poor quality machine made brick.

At 1.4 metres from the north-west corner an opening 0.8 metres wide had been constructed with two rows of handmade bricks laid with headers.

The wall is 0.5 metres wide and stands only as a single course over most of its length four bricks of a second course, all machine made, were found still in situ adjacent to the opening. The opening probably representing a doorway.

A deposit of demolition material and sandy-loam [006] covered an internal surface of sandy clay [012] probably forming the base for a paved floor. Fragments of flagstone 2 cm thick were found on the surface but not in situ.

The west wall is approximately 0.5 metres wide and used a different construction method. Only handmade bricks were present and the foundation had been built from 3 rows of brick with the outer and inner rows laid with headers and the middle row with stretchers. Only a single course survives. The west wall appears to be of an earlier date than the north wall which abuts it.

At the point where the west wall intersected the trench section there was a suggestion of a change in construction but time did not permit a further extension of the trench.

Both walls retained traces of a light greyish-white mortar.

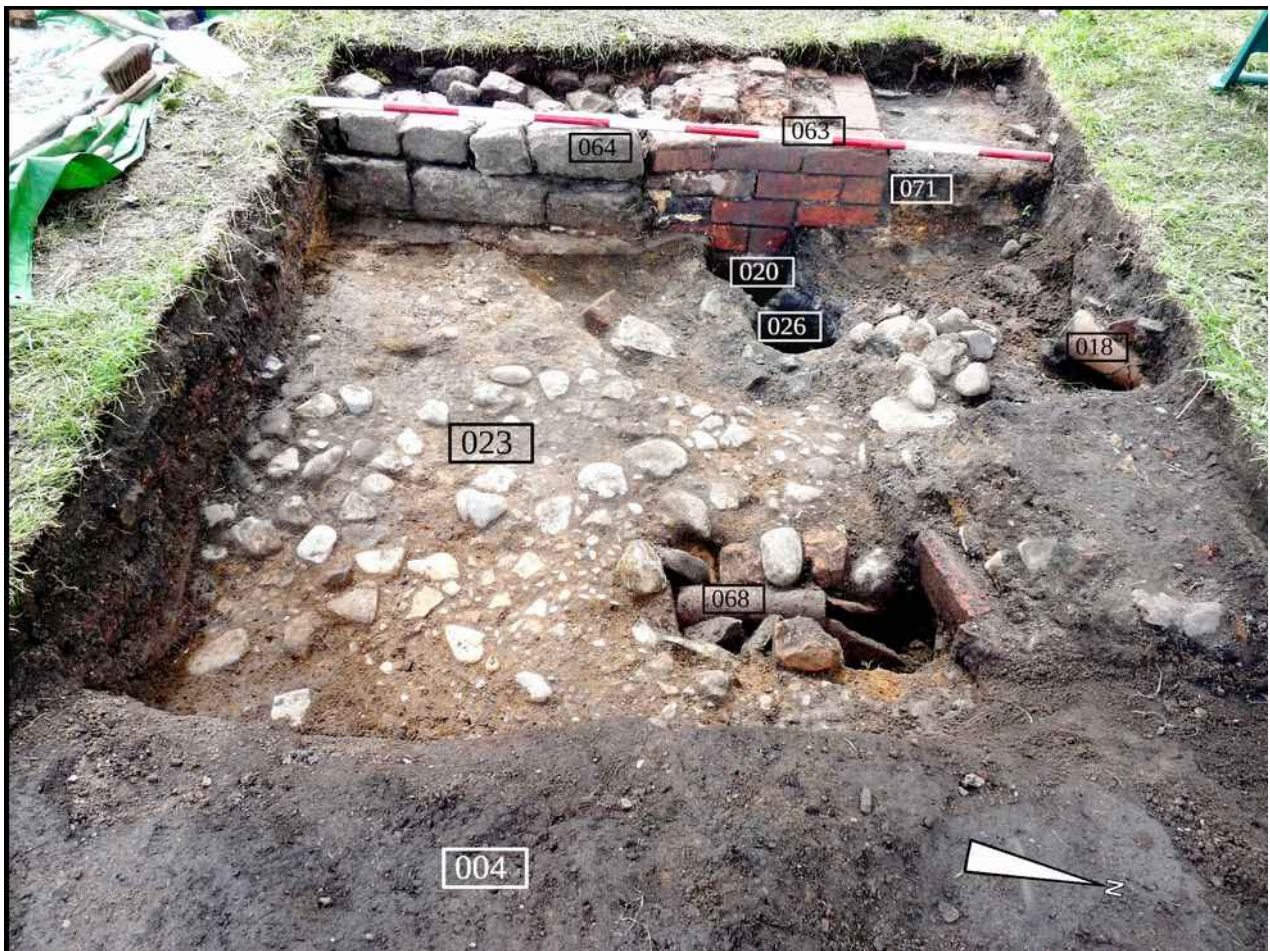
Tonge Hall Meadow Trench 06 – May 2013

A section of wall constructed from unmortared stone laid in regular courses extended from the southern trench section northwards for about 90 cm [064]. The wall consisted of 2 courses of a foundation layer of unfaced sandstone stepped out by about 8 cm. Above this are 2 courses of faced sandstone measuring about 10 cm x 10 cm and varying in length between 20 and 40 cm. Abutting this on the north side is the eastern end of the north wall about 0.65 m wide [063]. This was constructed from brick with four rows of handmade brick faced on the north (external) side with a single row of modern machine made brick (see T 10). The wall stands to 5 courses at the north-east corner with the bottom course probably being of older handmade brick.

To the east of the walls outside the building a surface of cinder 15-20 cm deep extended across the trench [004]. The upper levels contained a large quantity of 19th/20th century pot sherds. Cutting the cinder layer adjacent to the north east corner was a badly damaged earthenware drainpipe [018]. This extended from the wall to northern trench section. The cinder layer had also been cut by a shallow trench 50 cm wide and approximately 15 cm deep extending from the stone wall in a north-easterly direction. This was filled with a sandy-clay [016]. A quantity of modern bricks were present (not in situ) and it is thought that the sandy-clay represents a foundation layer for the boundary wall shown on 19th/20th century OS maps.

Removal of the cinder deposit revealed a deposit on stone and brick rubble [066] at the eastern end of the trench, possibly laid to level the area and provide additional drainage. This covered a cobbled surface [023] which extended across the trench but became sparser as it approached the walls. The cobbled surface had been cut to take a short section of land drain [068]. The cut had been backfilled with early handmade brick fragments and stone rubble and covered at its northern end by a modern machine made brick. Close to the north-east corner of the wall the cobble surface was again cut. The cut curved eastwards from the junction of the stone and brick walls before returning westwards and running parallel to the north wall at a distance of about 25 cm from the north wall [071]. The cut is filled with a dark greyish-black silty-sandy and humus and probably represents the foundation cut made when rebuilding the north wall in the late 19th century. The fill of this cut had been cut again by two post holes both about 20 cm in diameter and 25 cm deep. One is located adjacent to the eastern face of the brick wall [020] and the other about 5 cm to the east of the first post hole [026]. These post holes had been filled with a soft black humus containing some 19th century pottery sherds. The purpose of these is unknown but might have supported a boundary fence prior to the building of a brick boundary wall.

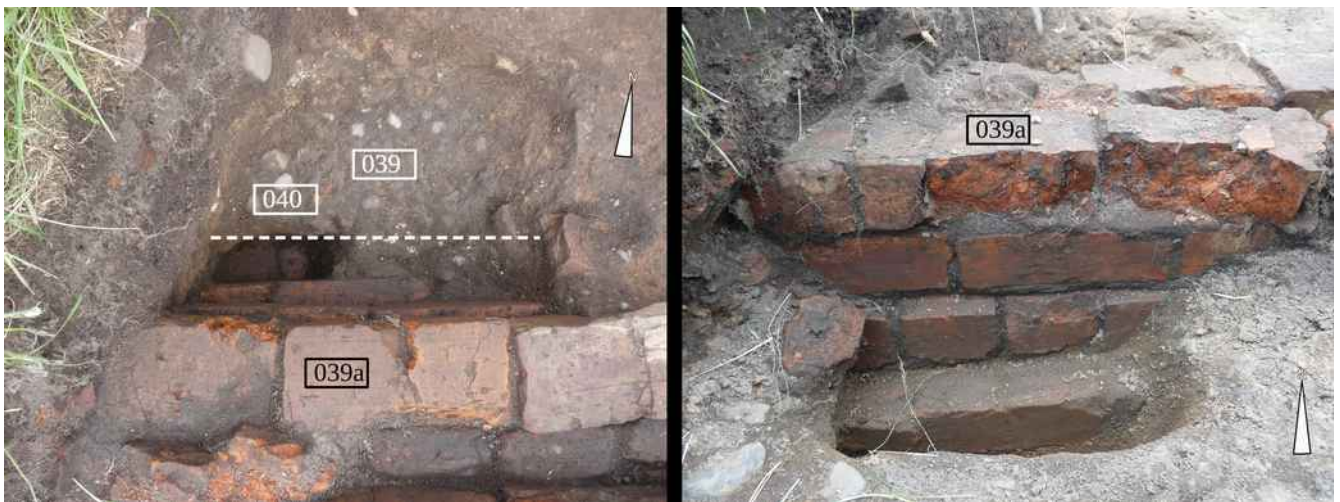
Tonge Hall Meadow Trench 09 – June 2013

Excavation exposed a brick wall [039a] formed by 2 rows of modern machine made brick laid with stretchers and set with a hard dark grey mortar. The wall was built with a cavity between the rows measuring about 10 cm at the west end but widening slightly to about 13 cm at the east end and partially filled with reused handmade half-bricks. The wall stands to 2 courses and on a foundation layer of 2 courses of modern brick laid with headers and each course stepped out on both sides of the wall.

On the north side (internal to the building) is a surface [039] composed of pebbles 2-5 cm in diameter set in a hard yellowish-brown clay through which the cut [040] for the wall foundation was made. On the south side the cut for the wall [042] is through a deposit of compacted sandy-clay and pebbles [043] similar to [039] and which probably formed a continuous surface prior to the construction of the wall.

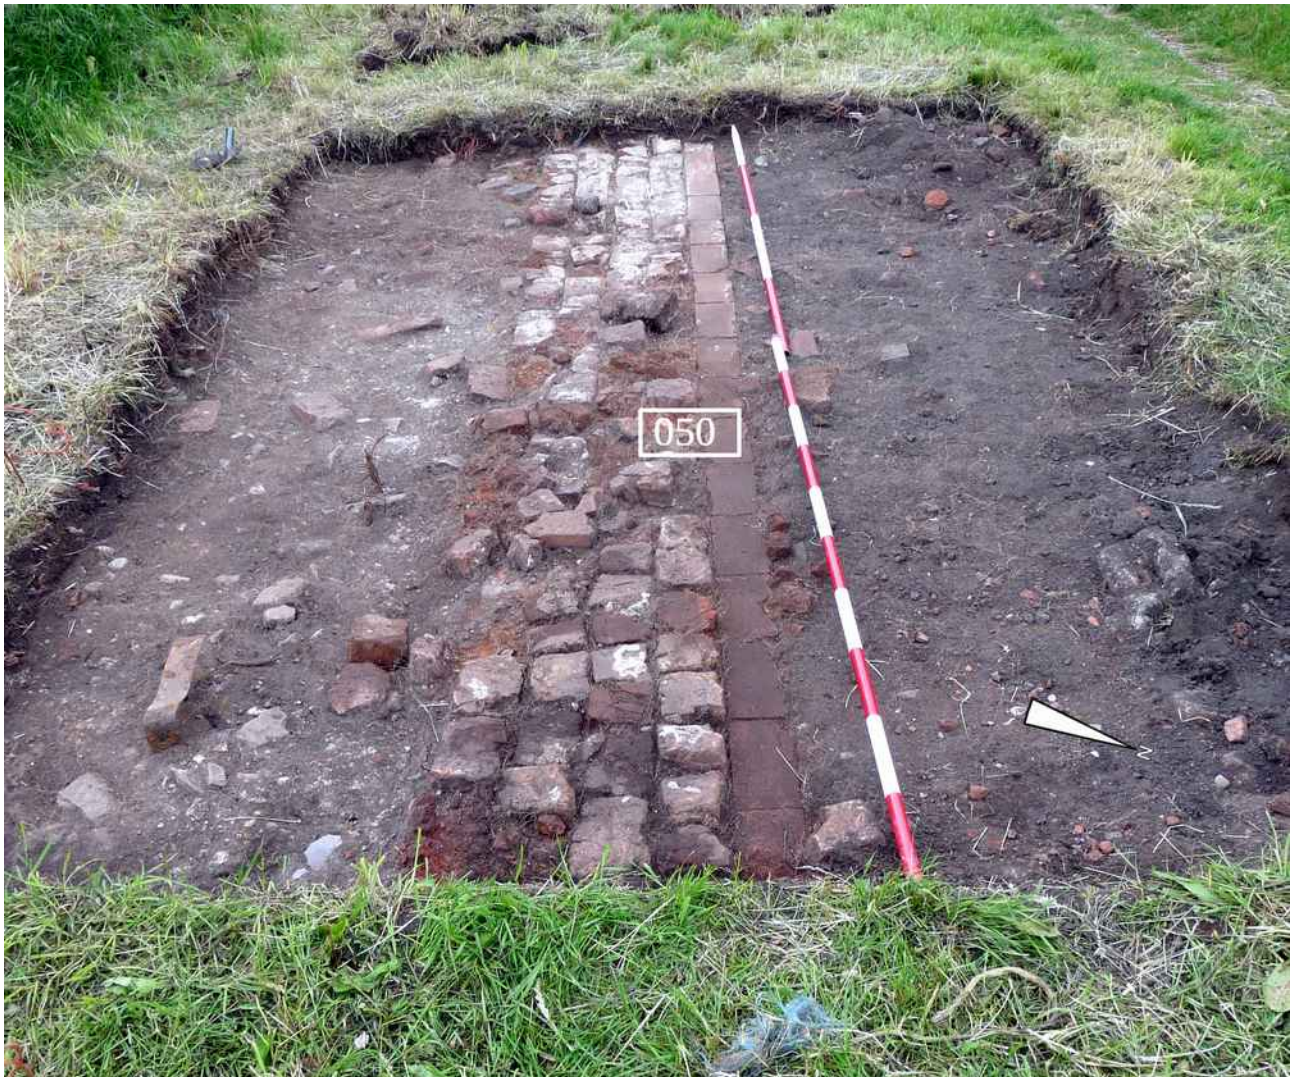
Tonge Hall Meadow Trench 10 – July 2013

A 4 m x 2.5 m trench located over the north wall of the farm house. Removal of the top soil and partial removal of the demolition layer revealed a section of the north wall spanning the entire width of the trench [050]. The wall was about 0.64 metres wide and consisted of 5 rows of brick laid with stretchers. The outer row on the north side is machine made brick and the rest earlier handmade brick. The wall at this point is one brick wider than at the western end in T 05 but identical to the section of wall revealed in T 06.

A small area in the south-west corner of the trench was cleaned to remove demolition material from the south (internal) side of the wall. This exposed a surface composed dark grey clay [051]. Poor weather and lack of time prevented further excavation in this trench and unfortunately prevented us from examining the western side of the stone wall excavated in Trench 06.

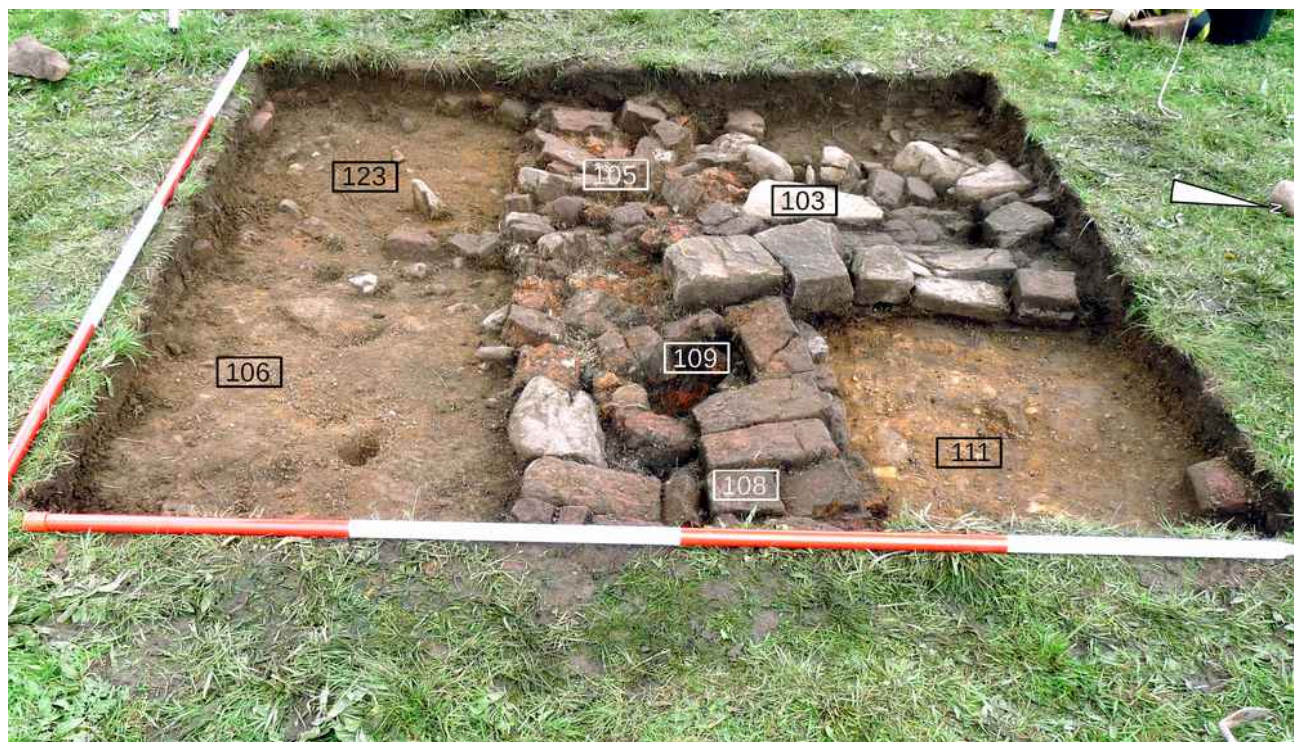
Tonge Hall Meadow Trench 12 – April 2014

The continuation of the east wall found in T06 ended at its junction with the east-west wall. Only a single course remains. Constructed of stone it is 0.8 metre wide. The eastern side (external side) is made up of large faced stones up to 25 cm wide. The west side is composed of smaller aligned stones up to 10 cm in width. The wall core is of stone rubble [103].

The east-west wall is of two phases.

The eastern section extends from the stone wall to the eastern trench section. This consisted of a foundation layer about 0.5 metres wide and composed mainly of brick rubble [105].

The western end appears to be of later construction and stands to four haphazardly arranged courses utilising machine and handmade brick and occasional large pebbles. It is 0.6 metres wide [108] and at the east end adjacent to the eastern stone wall the bricks are arranged to form a socket measuring 20cm x 20cm [109]. This may have held a door post since 20th century maps show an entrance at this point.

At the junction of the two brick walls there is a clear division in the floor surfaces. These would have been internal surfaces. The western end is composed of a yellowish-red sand [123] whilst to the east a 2 cm deep layer of yellow clay [106] overlies the sand. The north-east corner of the trench would have been external to the building and had a moderately compacted surface of reddish-yellow sand containing some gravel and occasional larger pebbles which might suggest that there had originally been a cobbled surface in this area [111].
