# The Old Boar's Head Middleton

## An investigation of foundations

### March 2016

Middleton Archaeological Society

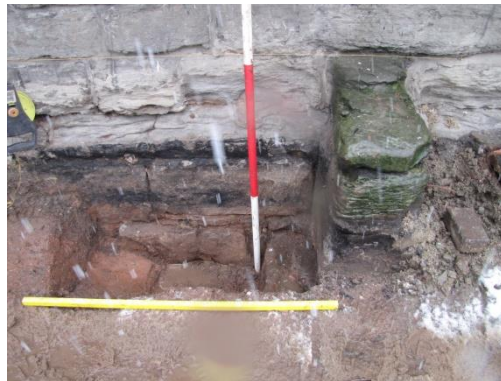
T2 Section

5.2.2. T2 was 1.0m by 0.5m. The trench was dug to a depth of 0.46m but failed to locate a cobbled surface. The southern side of the trench was filled with a sloping sand infill whilst the northern side had a gravelly sand infill. The exposed wall was in a much better condition than the wall above and was of finished sandstone similar to the wall above T1. Again the finished stone was of variable sizes and was laid upon small pieces of rough sandstone of 100mm thickness at a depth of 290mm. Larger pieces of rough sandstone were below this and appeared to sit on natural. These stones were slightly wider than the wall and appeared to be a foundation.

- 6.4. The foundations of Trench two were different to those in Trench one and appeared to consist of large wide stones with a small stone levelling layer on top. There is no cellar at this point so a difference in the construction of the foundations would be expected.

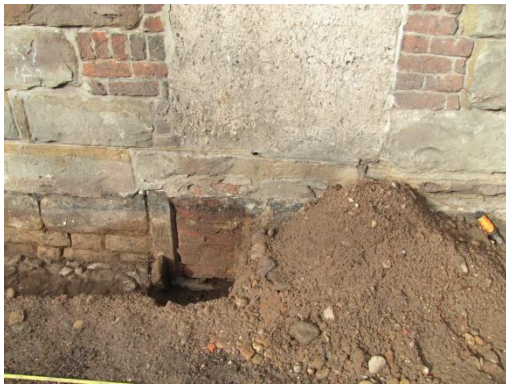
Left Cellar Window

At 1.4m along from the southern corner of the trench, a carved stone lintel frame with central mullion was identified representing a cellar window (1). The window had been infilled with handmade brick and mortar. The window light at the old pavement level had been infilled with a cinder and sand mix.

The wall above cellar window 1 appears to have had a doorway at some time that has been infilled. It was noted that this doorway and step would have obstructed the window light.

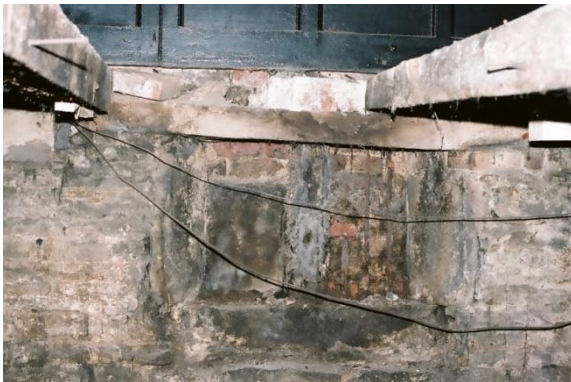
Left Cellar Window 1980s Internal

- 6.3. Photographs of the inside of the cellar taken in the 1980's are in Appendix Two and confirm that the windows were bricked up using machined brick (window 2) and handmade brick (window 1) It is noted in the 1888 photograph that only one window light (window 2) is present.

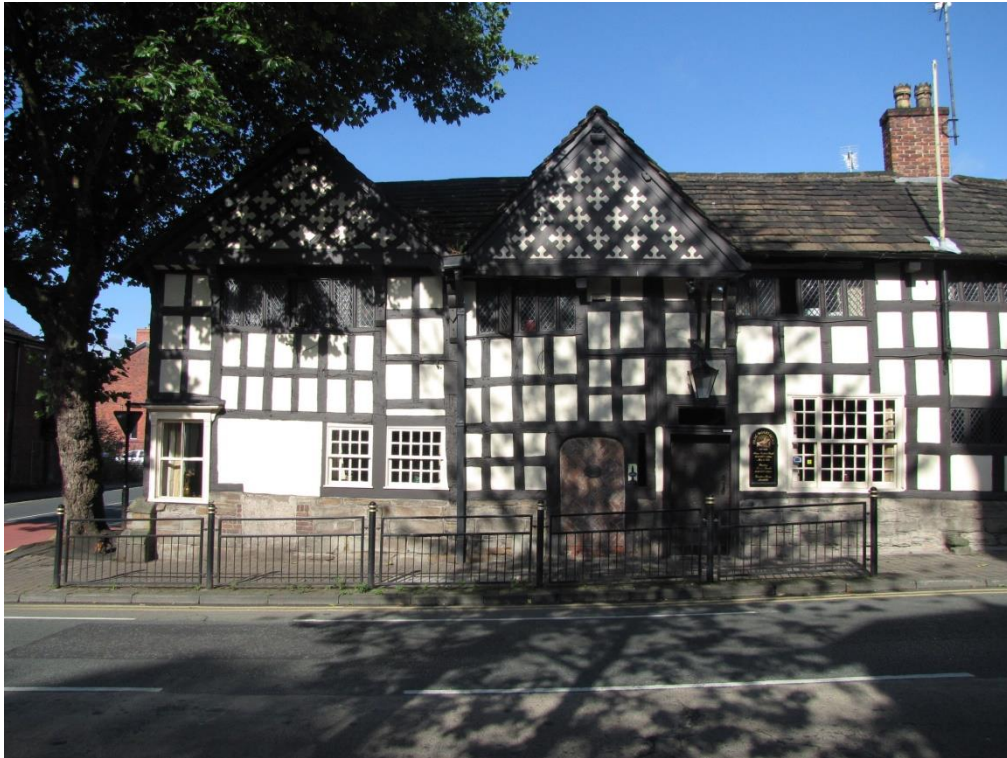
- 6.6. The exposed walls highlighted the poor condition of the stone above. This is most probably due to exposure to the elements and traffic pollution. As a follow up to this investigation, MAS will try to complete a scale drawing of the front stone wall in order to demonstrate its original appearance.

2016 prior to new paving

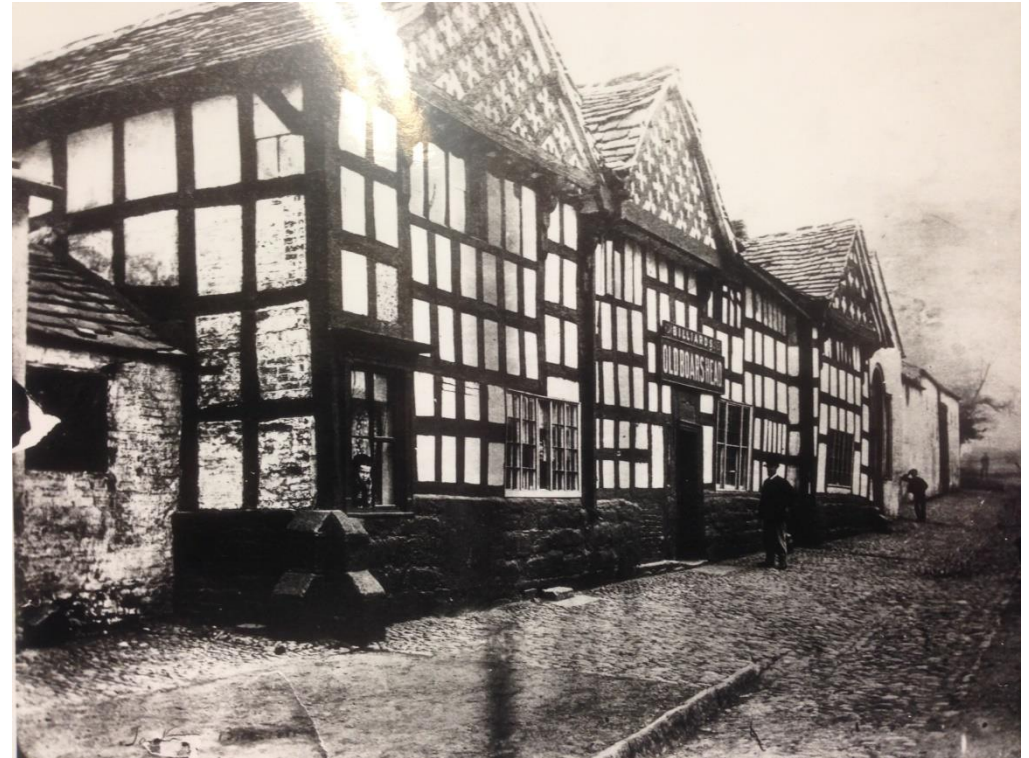
- 6.1. The investigation located an early cobbled pavement in Trench one which appears to be the one seen in the 1888 photograph in Appendix Two. The cobbles were found to have been robbed in the area of Trench two. The cobbles were butt against the pub wall suggesting they were laid later although it was not possible to date the surface.

1888 Showing Cobbles
