Summary of  
Archaeological Excavations at  
Hopwood Millers Cottage  
Middleton,  
Greater Manchester

**Robert J. Huddart**

Middleton Archaeological Society

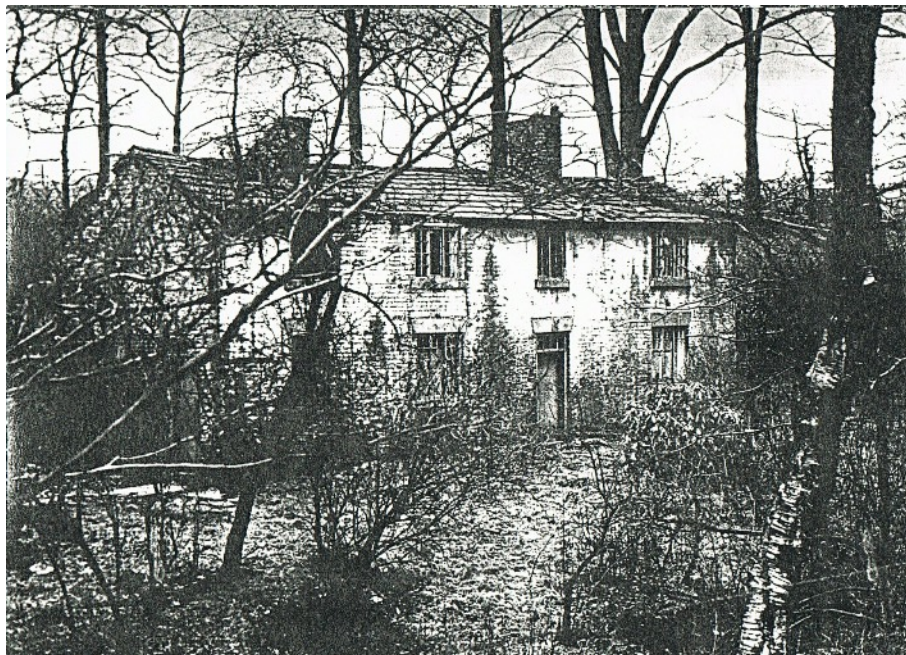
*Fig. 2 Photograph thought to be of Hopwood Millers Cottage*

The excavation also provided some confirmation that the 19<sup>th</sup> century photograph is of the Millers Cottage. Measurements taken from the photograph of the position of the chimney stack and the doorway corresponded closely with those of the excavation. Also the tree with the forked trunk which appears close to the south-west corner of the cottage in the photograph corresponds to the large beech tree which still stands in the same position.

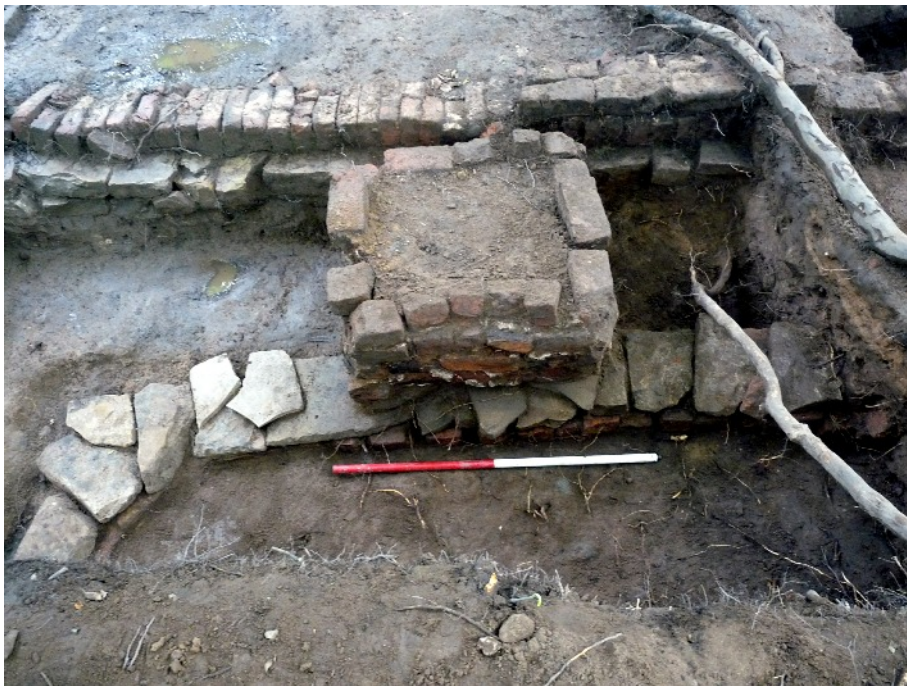
*Fig. 4. Internal Drain, Internal Wall and Chimney Stack*

The internal wall running north-south results in a single room at the west end of the building with internal measurements of about 4.5 metres by 4.5 metres. Within the room the base of a chimney stack was found [023]. Measuring about 0.7 metres by 0.7 metres it is located midway between the north and south walls, adjacent to but slightly separated from the internal brick wall and at a slight angle to it. The positioning is a result of the chimney stack having been built against the stone foundation supporting the internal brick wall which protrudes on the west side. There are four courses of brickwork mainly 18<sup>th</sup>/19<sup>th</sup> century in date and probably reused but also fragments of flagstone and one early brick have been incorporated into the structure. The chimney stack is set directly on top of a drain and post dates the drain and probably the internal wall.

The building was evidently prone to flooding. It had been observed during the excavation that whilst the top soil was free draining water during periods of heavy rain water rapidly accumulated on the natural silty-sand which lies at around 10-20 cm below the present ground level external to the building. To combat this plain horse shoe drains had been set directly onto the natural and laid parallel to both the north and south walls ([020] and [015]). These are probably late features. On the north side of the building they cut the cobbled surface which extends along the north side of the wall. Internal to the building the natural had been excavated down to a maximum of 50 cm below the outside level. The inside of the building had then been backfilled with a relatively free draining greyish-brown sandy-silt [035] and [029]. A thin surface layer of sand in the western room [006] may have formed a bedding layer for a flagstone floor. At a later date an internal drain [042] had been inserted by cutting through the sand layer and silty fill and into the underlying natural. The south-western end of the drain is inaccessible but the continuation runs parallel with the south wall turning north at about 0.8 metres from the internal and turning westwards to run parallel with the north wall exiting the building below the north wall foundation at the mid point between the west wall and internal wall. The outlet has not yet been found but is heading in the direction of the Trub Brook. The drain was constructed with a flagstone base, side walls of 2 courses of hand made brick and capped with flagstones including at least three reused roofing stones with peg holes. Internally the

drain measured 14 cm by 14 cm. It is likely that the drain did not remain effective for very long. When excavated it was entirely filled with sandy-silt [047].

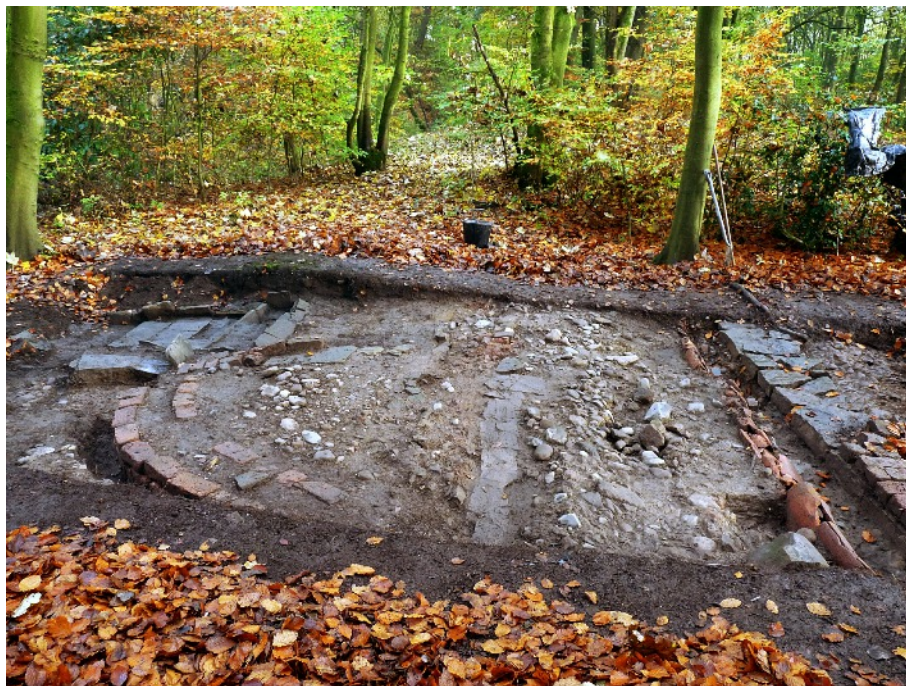
*Fig. 5. Garden Features*

A compacted cobble surface [059], probably a pathway, runs parallel to the north wall of the cottage. 1.2 metres wide it is bordered on the south side by the land drain and on the north side by a shallow gutter [012] at the west end and by the path to the bridge at the east end [004]. On the west side of the doorway is a shallow pit [038] loosely filled with cobbles measuring 80cm by 50 cm and 5 cm deep. The purpose of this pit is at present not known. Some patching of the cobble surface had occurred particularly at the western end where a compacted gritty sandy-silt partially covered the cobbles. There was also an area of consolidation on the north side of the gutter composed mainly of crushed brick but containing some larger brick fragments and angular stone fragments [040].

On the west side of the path to the bridge a curved brick feature [058] consisting of two rows of brick 20 cm apart extends from the path in a quarter circle towards the cottage. The outer row of bricks stands two courses high. Within the brick feature is a ring of small cobbles enclosing an inner ring of small pebbles [009]. The purpose of the feature seems to have been solely decorative and would have formed a level terrace against the fall of the land which is at this point sloping down towards the Trub Brook.

Towards the end of the excavation a sondage to the north of this feature revealed an earlier surface consisting of cobbles and angular stones following the slope of the land towards the brook [066].

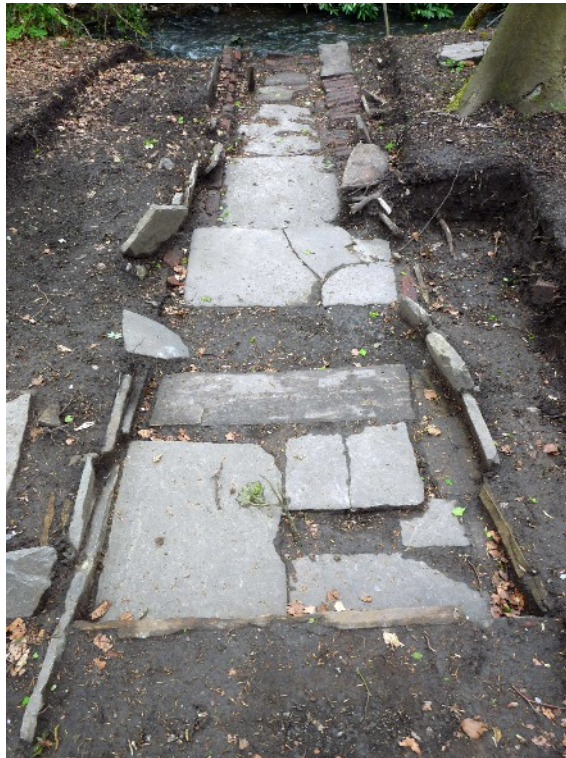
*Fig. 6. Path leading to Footbridge across*

A path 1 metre wide runs from the bridge south for 7.2 metres towards the supposed cottage door [004]. It ends about 2 metres north of the cottage where it meets a cobble surface which runs parallel to the north wall [059]. The path is paved with flagstones, bordered with brick and edged with flagstones 1-2 cm thick and set vertically to a height of about 10 cm. There were 4 intact shallow steps towards the south end. At a distance of 4 metres from the Bridge the eastern side of the path starts to diverge eastwards so that at 7.2 metres the path is 1.2 metres wide. This seems to be a modification to the original path. A compacted layer of silty-sand interleaved with deposits of fire ash may have formed a bedding layer for paving was removed to reveal features suggesting that the original line of the path ran parallel with the western side. Shallow depressions following the original path line indicate the removal of edging stones [065], a fifth step broken up in situ and the patching of the paving along the east side are all suggestive of the path having been altered.

An interesting feature was an inscription chipped into a large flagstone above the first step. The inscription “Bobbies Grave” [BG] probably marks the spot where a pet animal is buried.

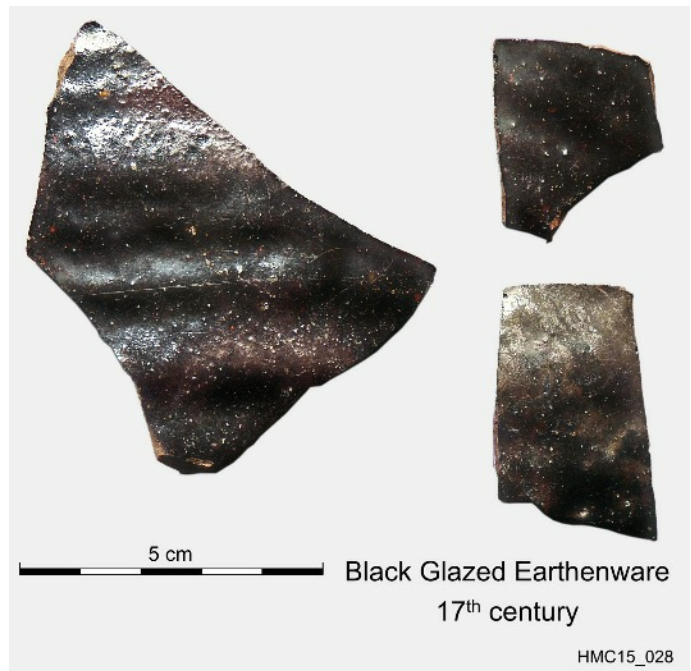
*Photograph 2*

The backfill internal to the building produced a few sherds of late 17<sup>th</sup> century pottery including two sherds of slipware (*photograph 1*) and three sherds of early black ware (*photograph 2*).

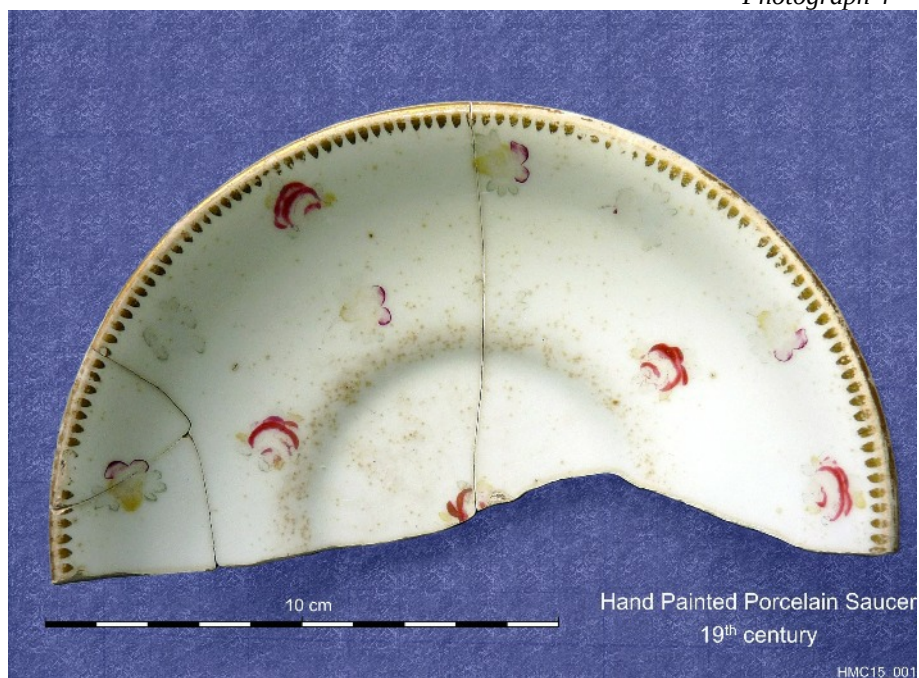
*Photograph 5*

Mostly only small sherds of domestic pottery dating from the 19<sup>th</sup>/20<sup>th</sup> century. These comprised of Coarse Black ware, Stoneware and White Earthenware's. A large sherd of a hand painted porcelain saucer probably dating to the 19<sup>th</sup> century (*Photograph 5*) was recovered from just outside the south wall of the building.

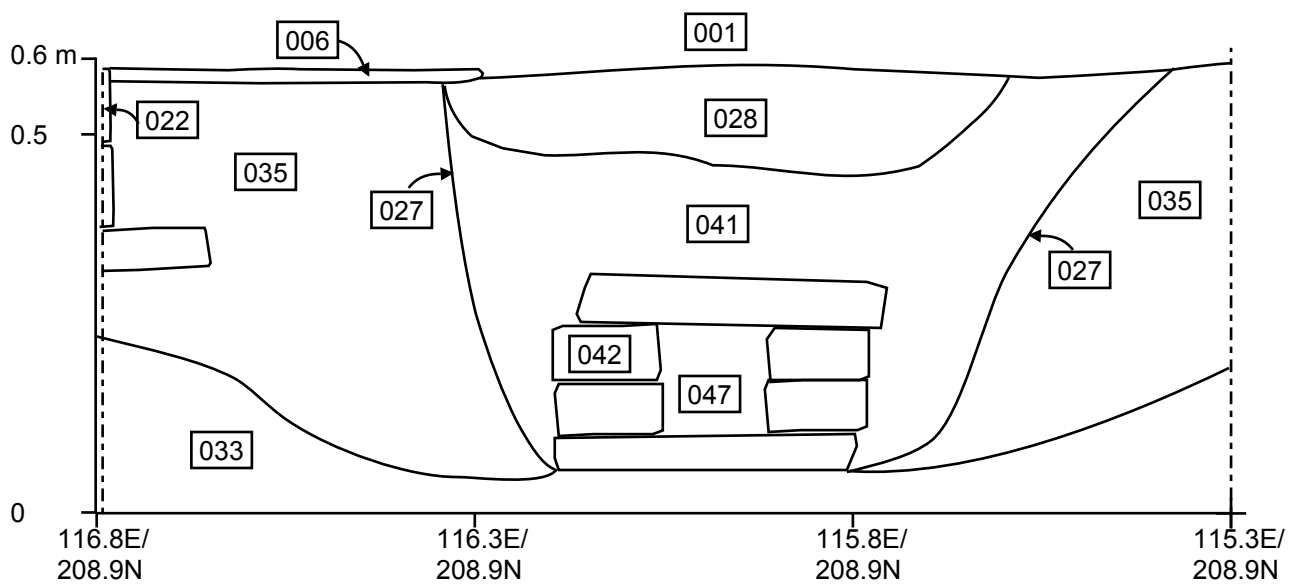
Drawing 5

Drawing 5:    Section Across Internal Drain.

Section Across Internal Drain (North Facing)

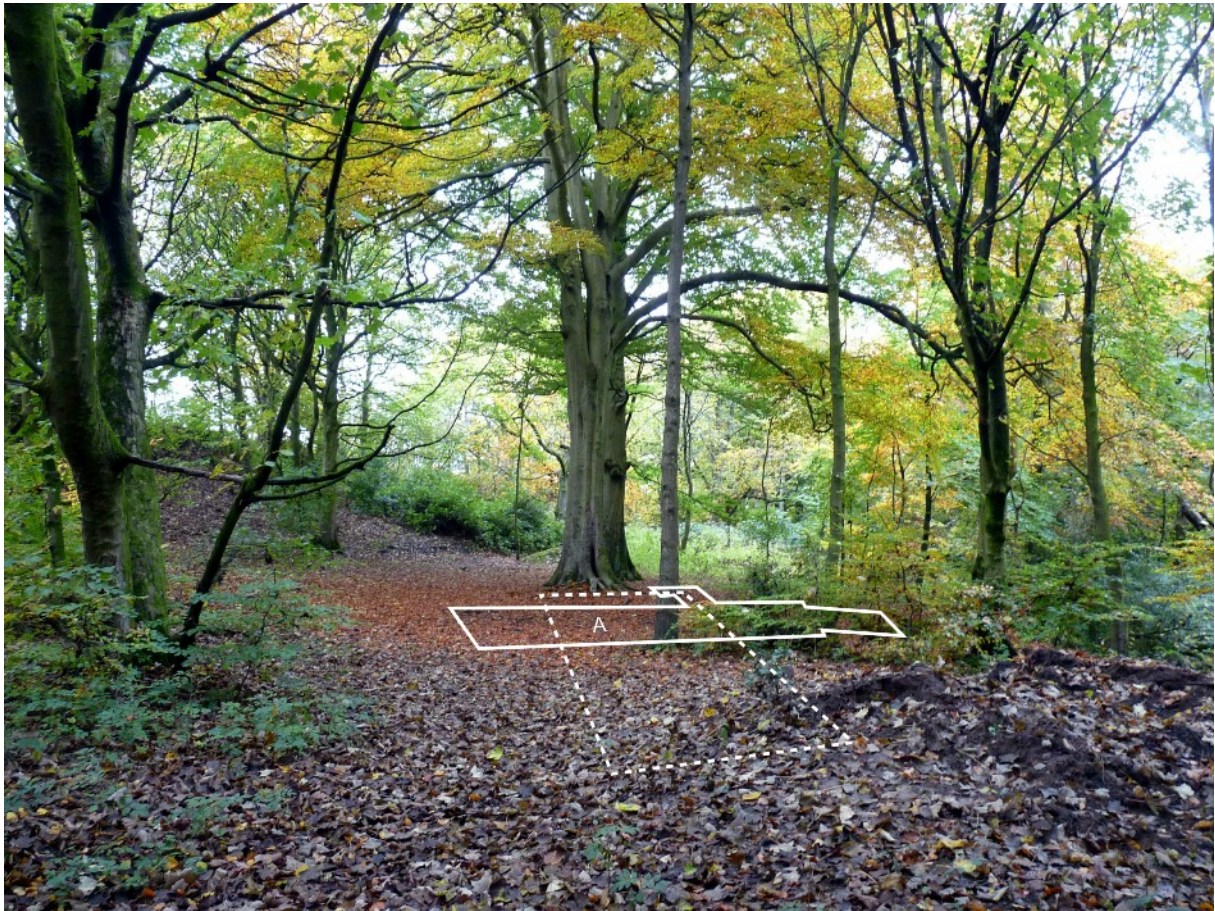
*General View of Hopwood Millers Cottage Site Looking West  
Solid line shows the position of Area A & broken line the approximate position of the Cottage*

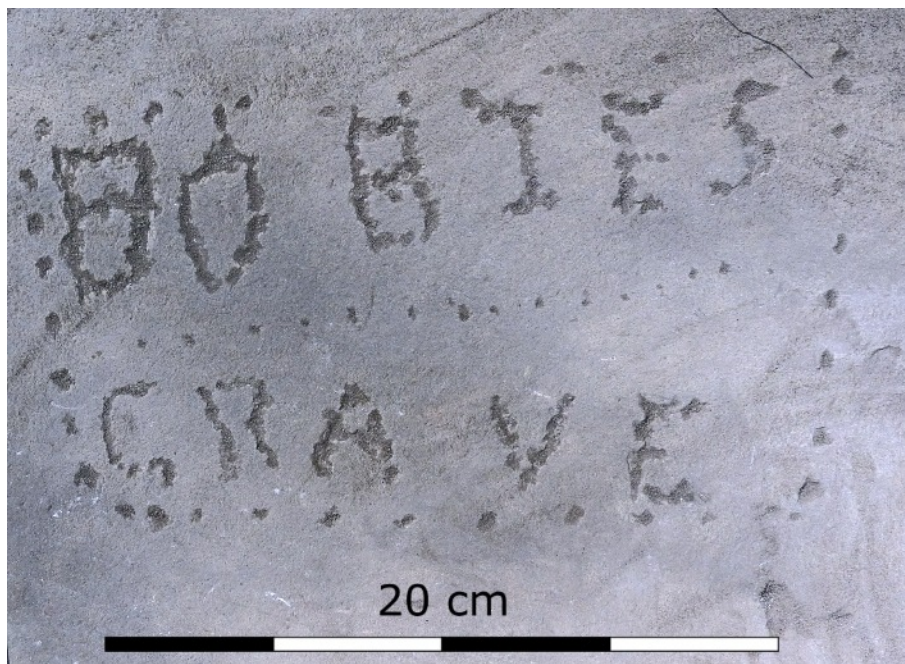
*“Bobbies Grave” Chipped into one of the bridge path flagstones.  
Probably to mark the burial of a pet animal.*

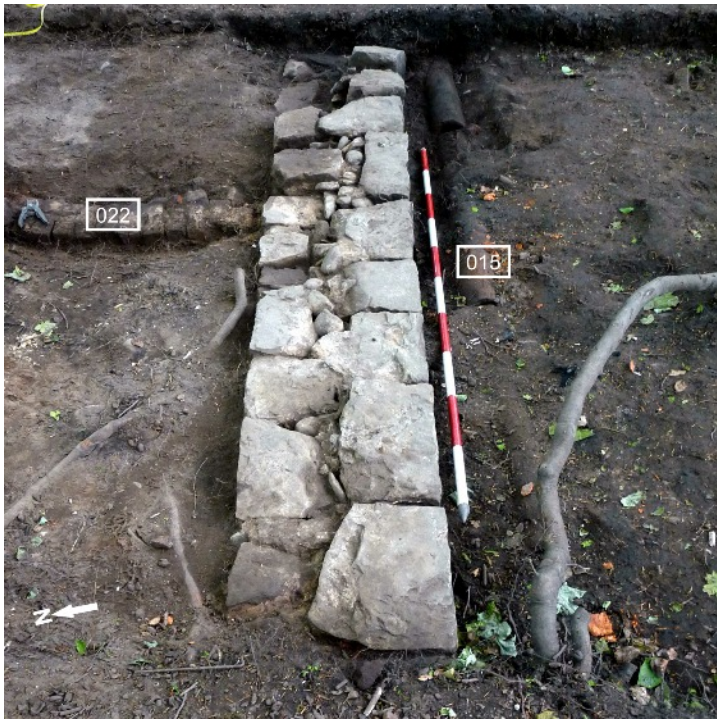
*Left. South wall of cottage.*

*Right. Bridge Support looking south from Trub Brook.*

*The wooden foot bridge was secured by two large bolts. A fragment of wood is still in place.*

A footbridge across the Trub Brook allowed access a water spring on the north side of the brook. The bridge has been dismantled but both bridge supports are still in place. The support on the north bank is difficult to access due to fallen trees and a large rhododendron bush. The support on the south bank was examined. It is constructed mainly of brick on a flag stone base and measures 1.1 metres by 1.1 metres in plan and is 0.7 metres high [007]. The north, west and east sides are constructed from modern machine made brick (including frogged and plain brick) in two rows and to a height of 8 courses on the north face. The inner core could not be examined in detail but appears to be mainly of concrete topped with a layer of brick. The bridge was secured by two vertical iron bolts and was constructed from timber a fragment of which is still in situ. The cartographic evidence suggests that the bridge was constructed towards the end of the 19<sup>th</sup> or early in the 20<sup>th</sup> century and this is not contradicted by the archaeology
