Hopwood Millers House Excavation – Historical Background

Excavation

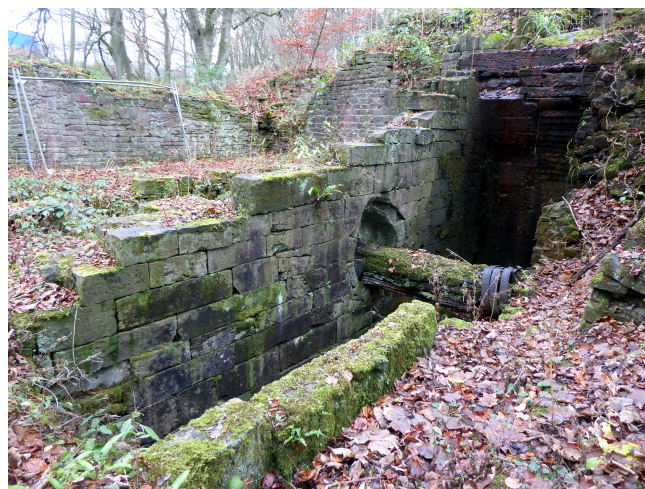
Hopwood Corn Mill November 2018

It is possible that the surviving pitwheel pit was originally constructed as a wheel pit in the late 16th or 17th centuries but the body of the mill dates to the 18th century.

In the early 19th century the wheel pit was widened and two wings built. The North-West wing being a corn drying kiln and the East wing a granary.

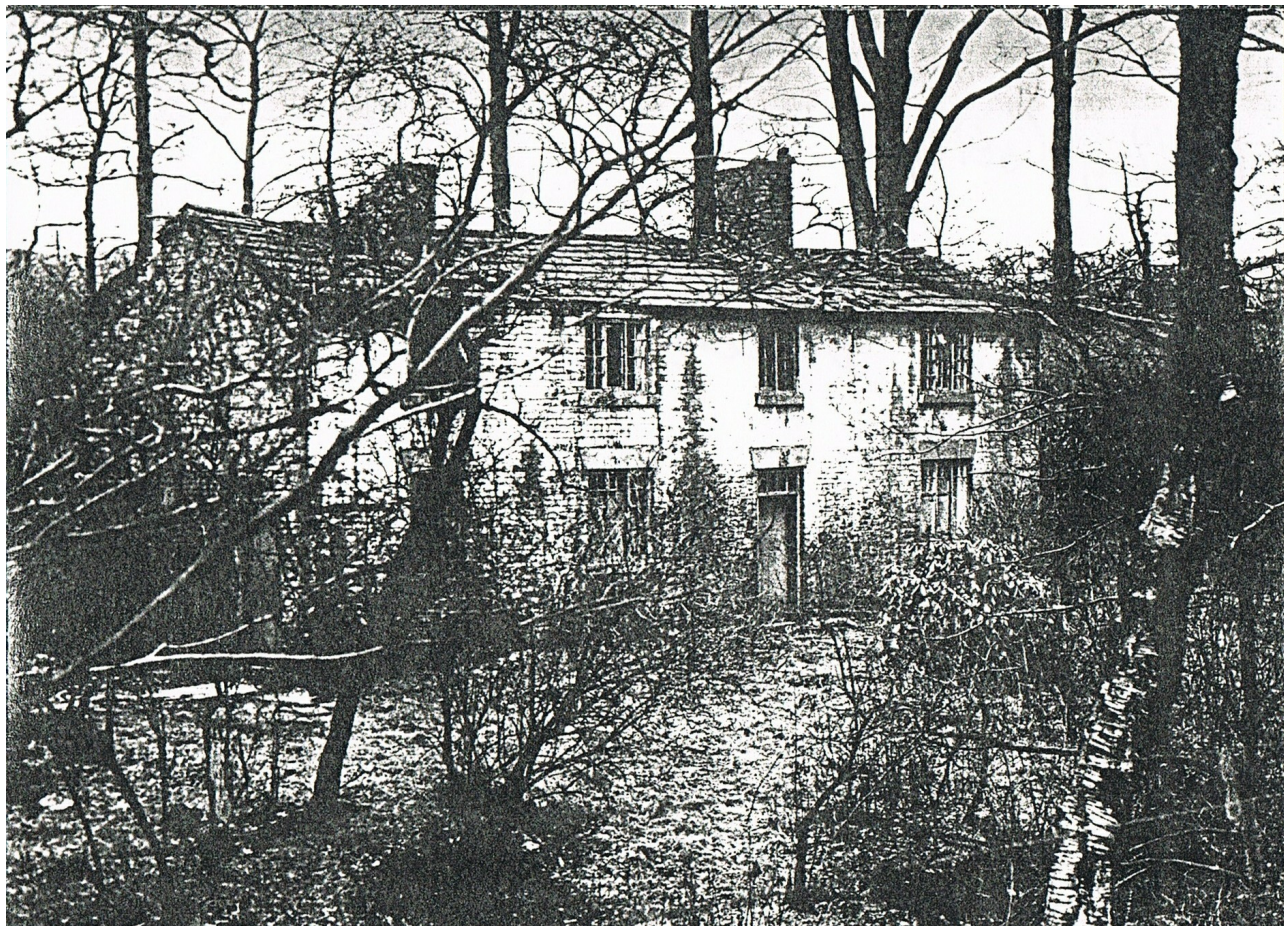
The photograph shows the North side of the house. It shows a double fronted house with the workers house at the East end (left hand side).

The building appears to be in neglected condition and in a poor state of repair. It is probable that the photograph dates to about 1880 but prior to the refurbishment which took place at around the same time.

In 2017 we had a ground plan of the house including the location of doors and chimney stacks. By comparing the archaeology with the photographs we were able to identify the photograph below as the millers house.
