Millers House late 18th century to 1880

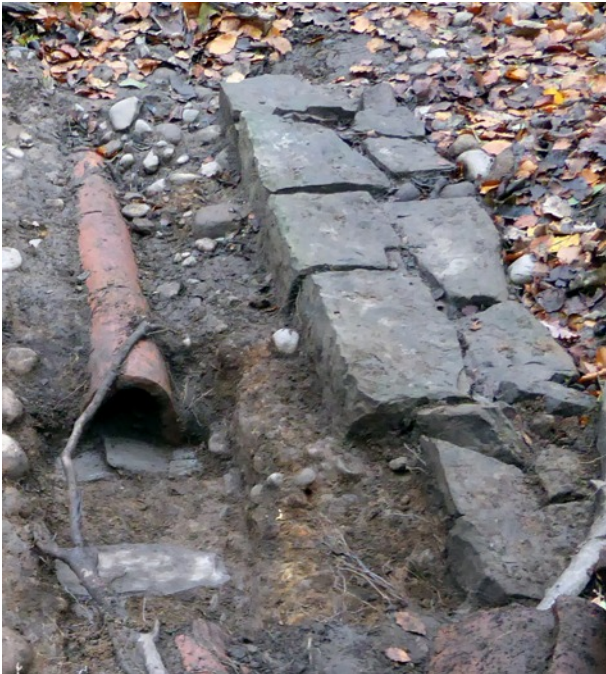
Eastern foundation of north wall. 50 cm wide and using larger sandstone blocks on outer side of wall.

There was some evidence for this extension in the archaeology. At 9.2 metres (30 feet) from the north-west corner of the house the stone foundation of the north wall increases by 10 cm to a width of 50 cm. Additionally the stonework at the eastern end is of a higher quality and constructed from large sandstone blocks, squared and aligned along their outer edges rather than the less regular flagstones used at the western end.

The location of the change in foundation width corresponds to building of two bays each measuring 4.6 metres by 4.6 metres with the later extension being at the east end.

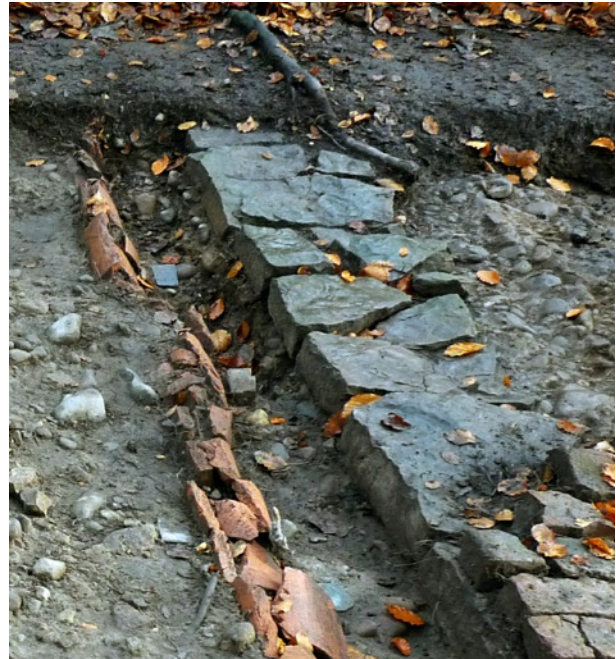
Western foundation of north wall. 40 cm wide using irregular flagstones.
